AIRLINE-CRASH TRIFECTA

Misfortune is said to come in threes and last summer was no exception. Three high-profile accidents grabbed headlines and offer lessons for our flying.

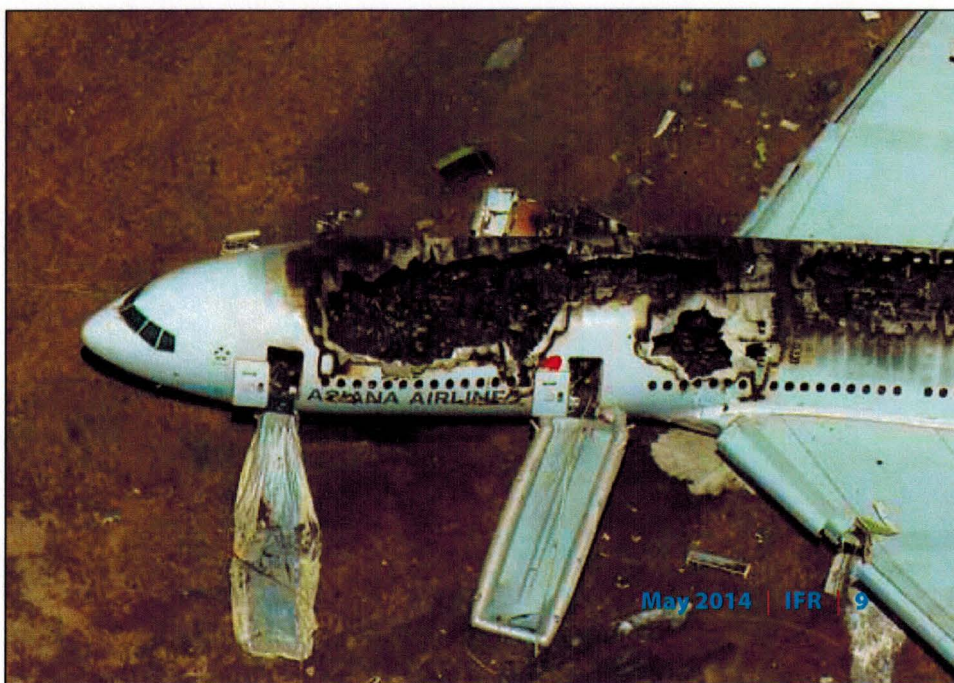
RIGHT: For such a horrific aftermath, Asiana 214 suffered amazingly few injuries, all of which might have been avoided by a judiciously timed go-around.

There were a couple of decision points where the tragedy could have been prevented. The initial switch from FLC to a 1000 fpm descent was one occasion. When they recognized that descent wouldn't work they should have gone around. Once the climb was inadvertently initiated by FLC, they ought to have gone with it. Being a training flight, perhaps neither the student nor his instructor wanted to risk looking bad to the other. Finally, checking that they were stabilized would have told them something was wrong.

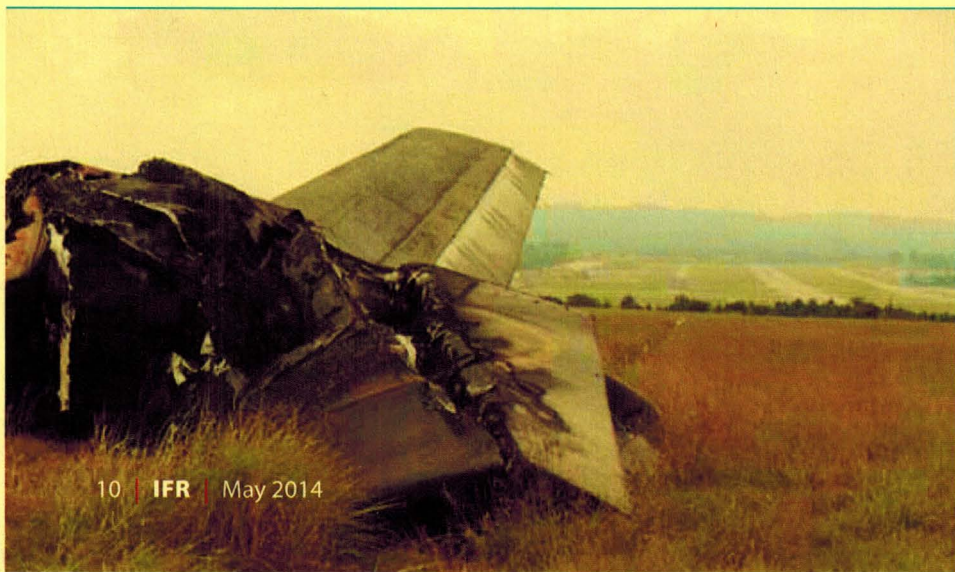
LEFT: Indications are that UPS 1354 chased the FMC glidepath below MDA, crashing just short of the runway.

They reached the final approach fix 200 feet high and the captain realized the autopilot was not going to capture the armed vertical glidepath. The 3.28 degree angle for the approach is a bit steep and starting higher didn’t help.

The captain initially selected a normal vertical speed of 700 fpm, but soon realized he needed more, and selected 1500. The first officer made a standard 1000-foot call as they descended at 1500 fpm until the enhanced ground proximity warning system shouted, “SINK RATE, SINK RATE.” At that point the captain reduced the vertical speed and called the airport in sight, seconds before impact. Approach minimums were never called and the reported ceiling was 200 feet below the MDA.

The Airbus 300 requires three familiar steps to fly a profile approach: load the approach, activate the approach, and sequence the flight management computer (FMC). The crew skipped the last step—the computer was still navigating directly to the airport—so the armed vertical glidepath wouldn’t capture but it did offer multiple cues the crew missed.
